Cavitation Process and the Performance of Some Ferrous and Non-Ferrous Alloys

Abstract

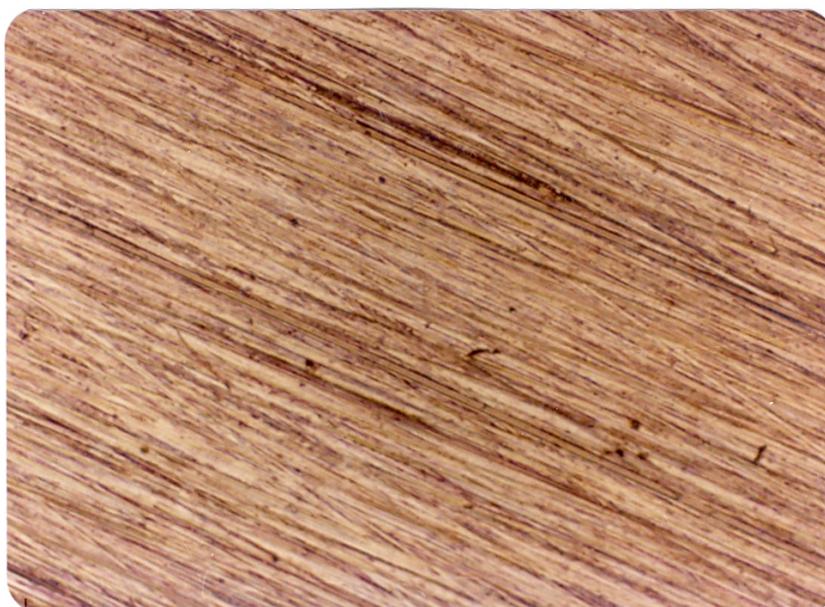
Figure 6. Carbon steel (AISI 1020) polished with 600 SiC paper Mag. x 80.

only difference noticed visually was their color. Figure 6 and 7 show alloys carbon steel (AISI 1020) and stainless steel (AISI 304) in their original state.

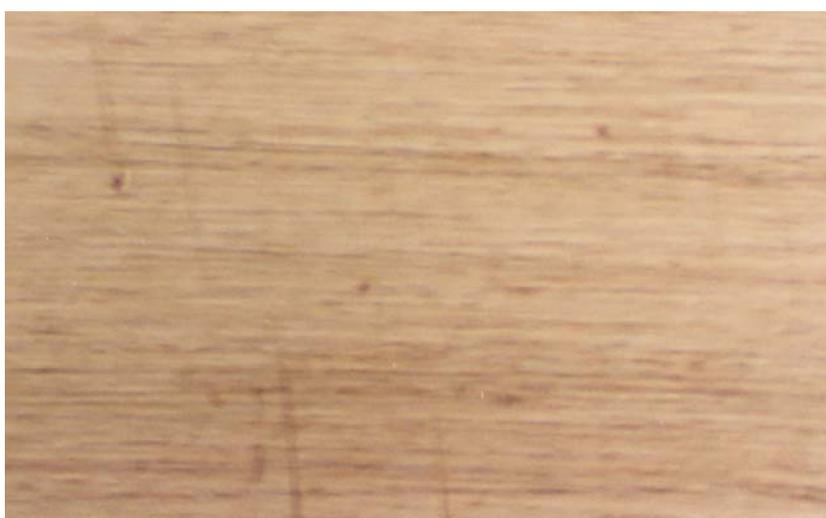
Figure 7. Stainless steel (AISI 304) polished with SiC paper Mag. x 200

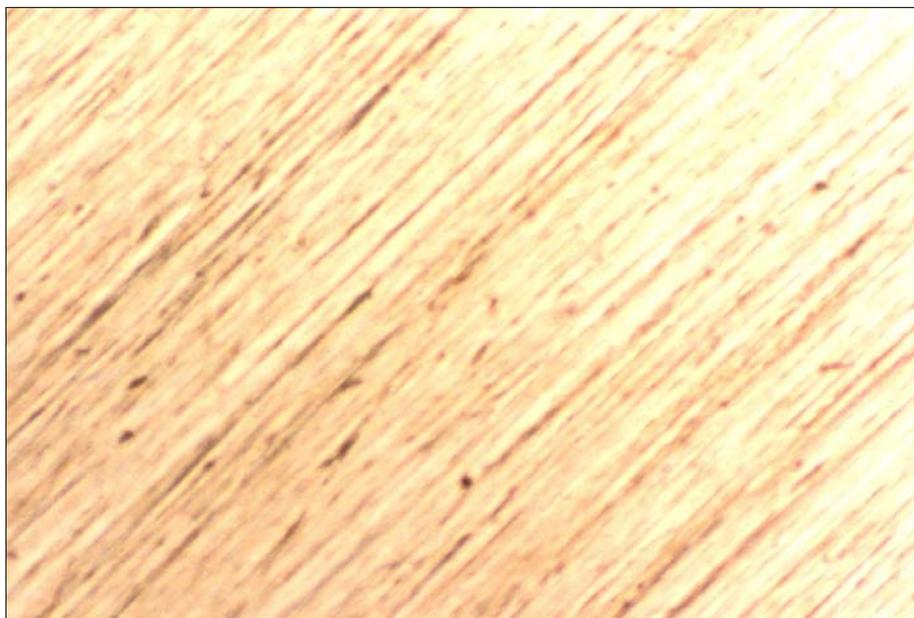
Figure 12. Stainless steel AISI 304 was lightly attacked (pitted) Mag. x 100

Light microscopy examination showed that stainless steels 304 and 316 were only mildly attacked, and in the worst places the surface only exhibited shallow pits (Fig. 12, 13).

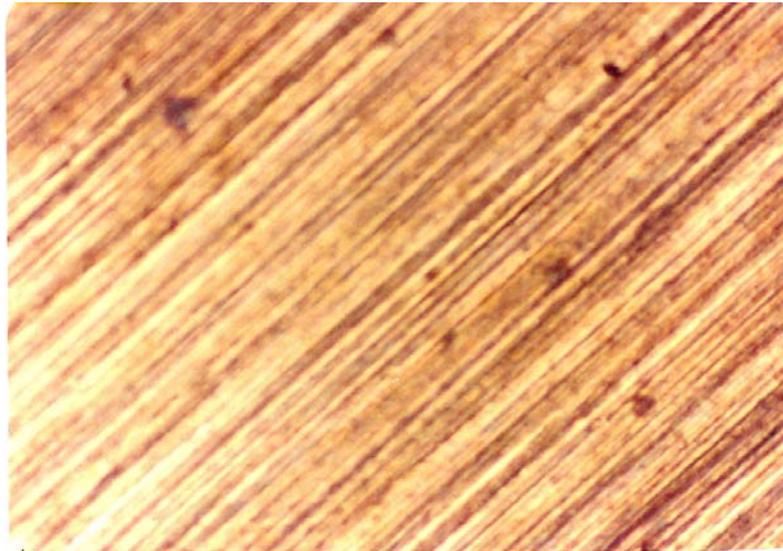
Figure 14. P-Bronze (C51000) after 60 min exposure showed slight pitting Mag. x 100

Phosphor bronze behaved better than the previously discussed alloys, with very few pits, (Fig. 14). The cavitation (erosion) pits nature and the time it took for them to be revealed are in accordance with other workers research [3,25]. This alloy had a relatively high hardness of 86, but a low tensile strength of 455 MPa. One may suggest that the best material ranking is obtained using a resilience number[20] (Fig.15). The American Society of Metals [24] also pays detailed attention to material selection for such applications.

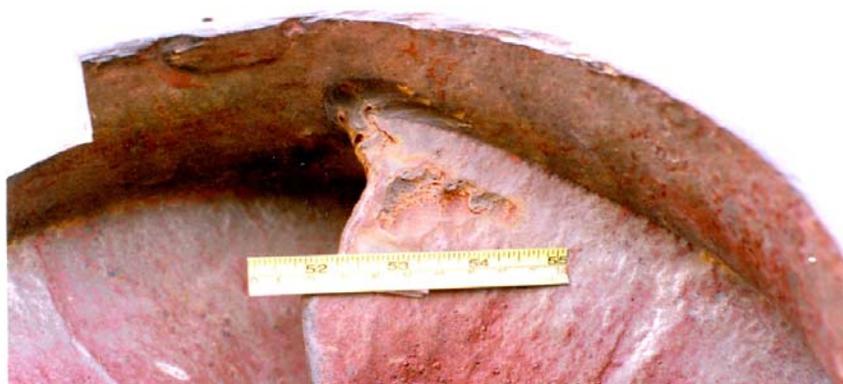
In an another extensive field study on the centrifugal pumps of the Iranian sugar cane industry [15], it was concluded that if the hydraulics hydro-dynamic conditions of such pumps were not met, cavitation erosion-corrosion could damage the pumps parts (Fig. 16).

Figure 16. Cavitation erosion-corrosion of a centrifugal pump's impeller

As it was noticed after only a few months of service, the cast iron impellers and the casings were attacked. As a result, the integrity of the pump design was degraded; the pump efficiency was reduced [15]. The circulating fluid was brine water containing sand particles extracted from the artificial water flooding of Khozestan farms which were being rehabilitated for sugar cane farming. Figure 17 shows the microstructure of the impeller's gray cast iron in its polished and etched state. The fluid approaches the impeller blade with larger and larger angles of incidence altering the velocity and pressure fields inside the impeller. Suction recirculation [22], stall and separation of the fluid leads to reversal flow in the pump. For

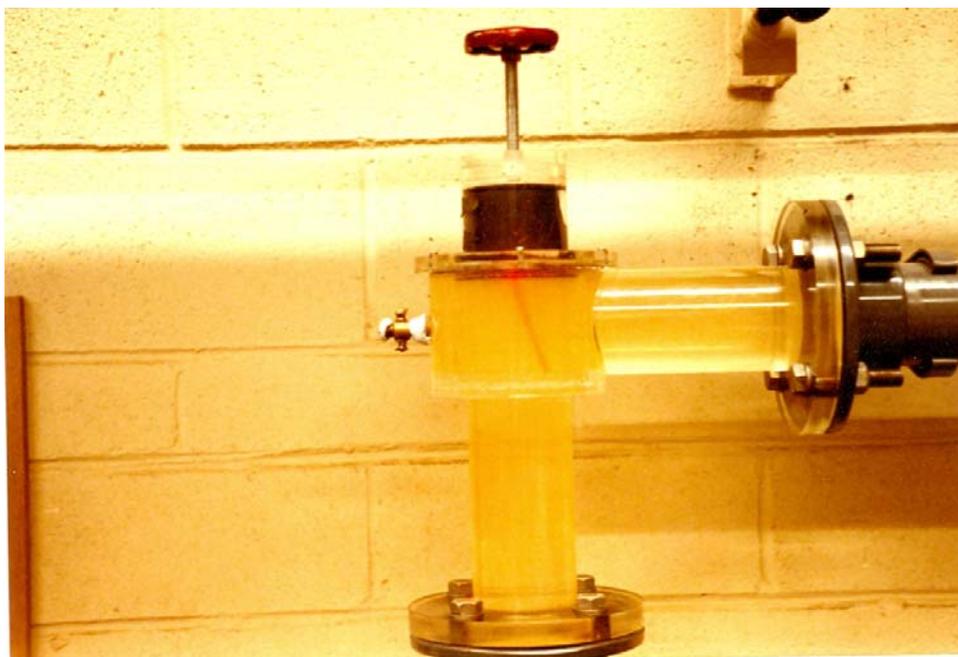
conditions of a petroleum industry's well head choke valve was conducted (Fig. 18). I also tried to apply the laser beam via-a-vis a computer program to statically number the cavitation population.

Figure 18. the constructed choke valve

When the piston; the actuator, (Fig. 18,19) was fully out, flow rate was at its maximum with the highest static and dynamic pressure drop. With the rig's flow condition described in the experimental section, a cavitation cloud developed in the choke valve. As the piston was traversed forward, the flow rate decreased, cavitation bubble production emerged with noise and vibration continued. As was gathered through the above results and discussion, to protect against cavitation erosion-corrosion, design (cavitation number and N.P.S.H.) and material selection [24] are the two main important factors to be considered. Decreasing the flow rate, increasing the piping diameter, reducing sharp section changes and controlling the cavitation number and net positive suction head are the main design factors to be met. Hard surface laser treatment coating has been [11], surface roughening and dampening may also be applied. Mathias et al [17] suggested that the cavitation process is similar to shot peening, thus by introducing surface compressive stresses one may harden the material against cavitation damage. Proper selection of the material; Stellite, Al-Bronze, etc is also suggested, or resistance coatings may be applied [26].
